# Advantage Home & Property Inspections LLC Property Inspection Report

522 Puka Puka Avenue, Somewhere Idaho Inspection prepared for: Mr. & Mrs. Sample Agent: Dominic Maricic - Home Inspector Pro

Inspection Date: 6/29/2009 Time: 9:00 am Age: 1982 Size: 2200 sq. ft. Weather: appx. 75 degrees Log Home

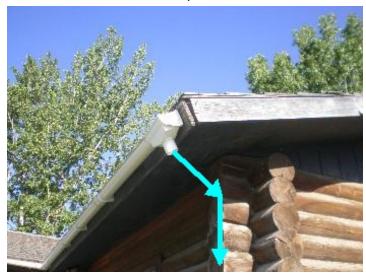
missing down spouts

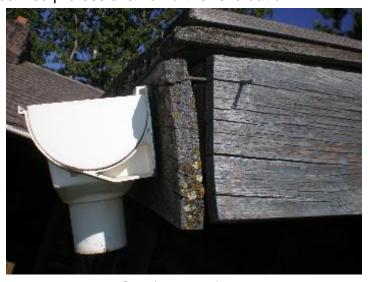
Split/gapped facia

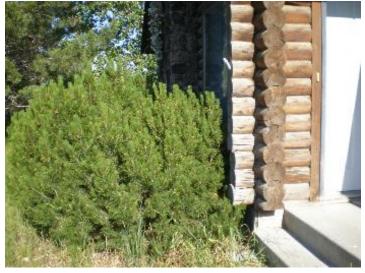
Trees/shrubs overgrown/contact with structure in some areas (recommend trim to prevent damage)

Chinking missing/deteriorating in some areas

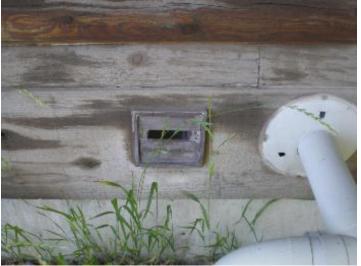
Dryer vent cover damaged/ missing

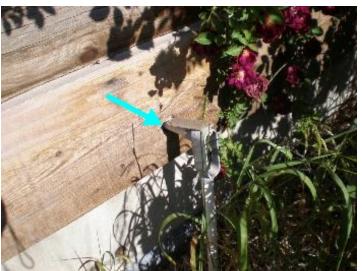
Exterior penetrations not sealed to improve caulk/reseal to prevent moisture/insect penetration

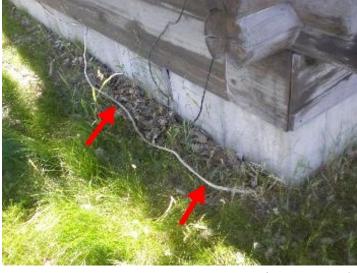
exposed unanchored romex wiring, (evidence of broken insulation)

exposed romex wiring, (evidence of broken insulation)

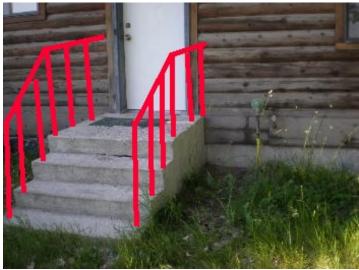
No hand railing (4 or more steps require a handrail)

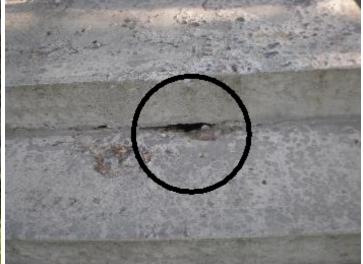
Rear concrete steps have hole present, (recommend seal to prevent moisture/insect intrusion)

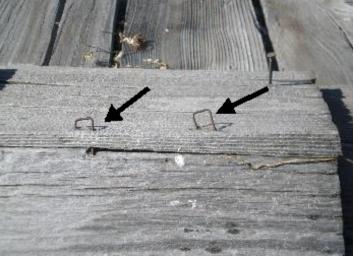
Broken shingle

Ridge cap nails/staples backing out

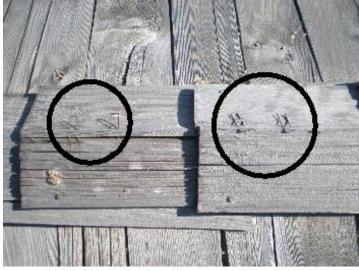
Ridge cap nails/staples backing out

Metal used as starter course loose,needs reattached

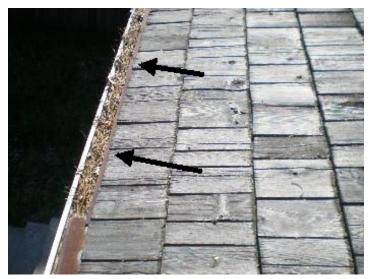
restricted by debris (recommend clear to improve drainage/flow)

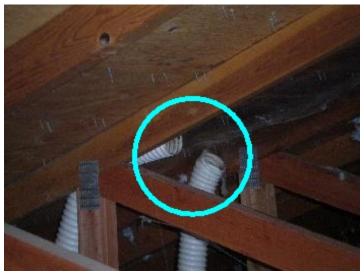
Bath exhaust fan does not vent to the exterior (causes moisture build up/possible dry rot)

Evidence of possible micro-bio-growth (due to improper ventilation)

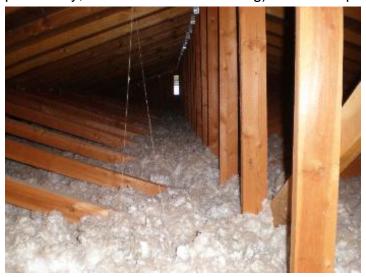
recommend adding additional vents (to improve only, adds life to roof covering)

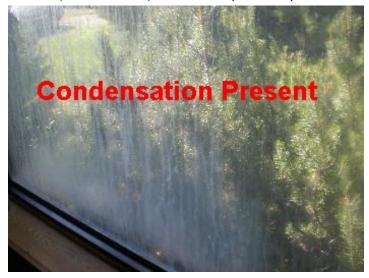
evidence of condensation at some windows (Seal broken)

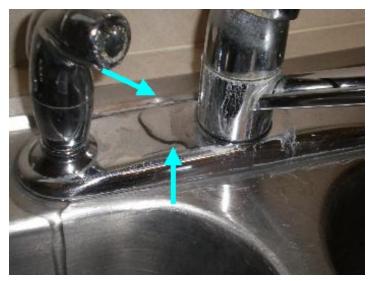
Faucet leaks while operating

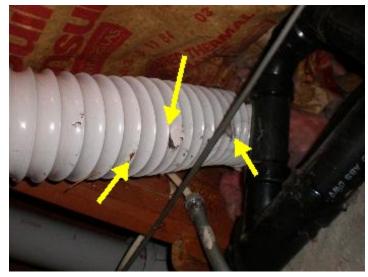
damaged vent pipe

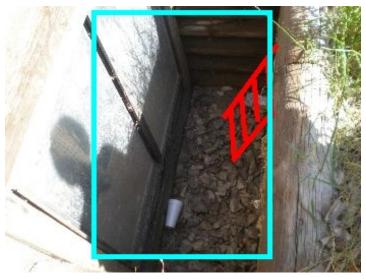
Open window well; The windows are of egress type, to improve, recommend install a fixed window well ladder and covers (safety)

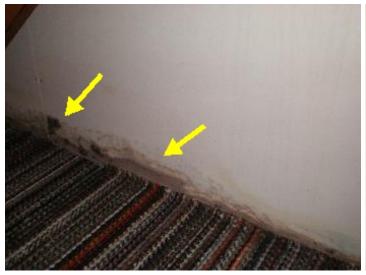
Evidence of water/moisture infiltration from mechanical room (possible micro-bio-growth present, Consult qualified professional)

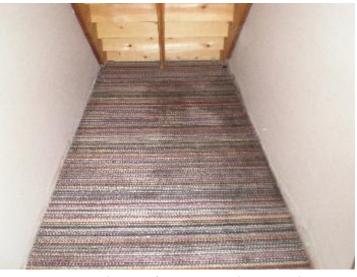
Evidence of water/moisture infiltration from mechanical room (possible micro-bio-growth present, Consult qualified professional)

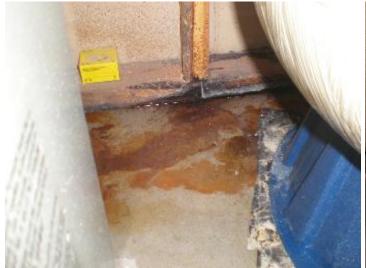
Evidence of current leak at pressure tank

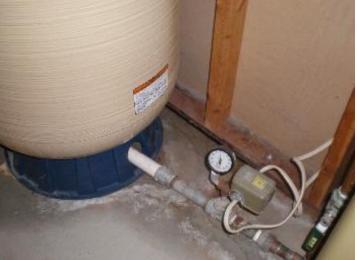
Evidence of current leak at pressure tank

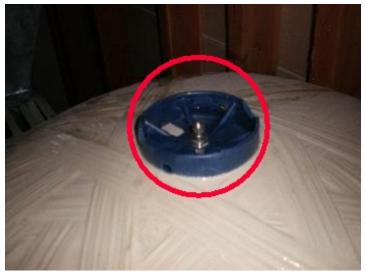
Evidence of standing water at pressure tank relief valve

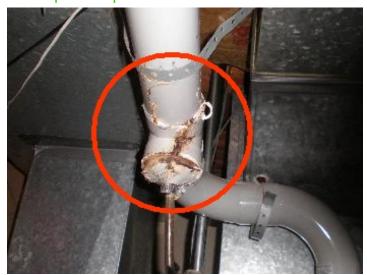
Damaged vent pipe (evidence of unsuccessful repairs)

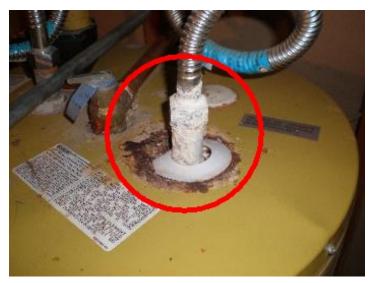
corrosion present (possible di- electrical reaction) dissimilar metals

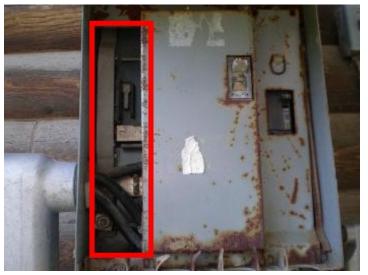
missing inside cover

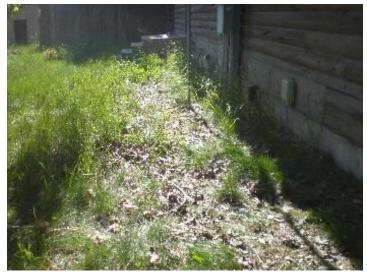
Flat or slopes towards structure in some areas

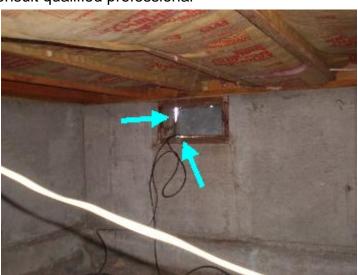
Vents not properly secured, Gaps present due to cable installation allowing insect intrusion, recommend seal/re-attach

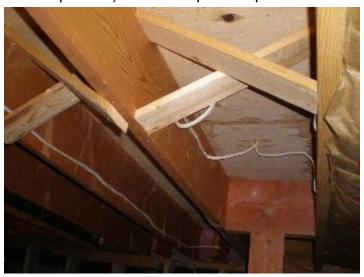
Only partial insulation installed, (rolls of insulation present)
